Service Log AN/GRC-109
PP2685 PSU recapping and misc,
18-Nov-2023, Virgil Cheng vr2xgm

PP2685 recapping and AC meter replacement, 17-Nov-2023

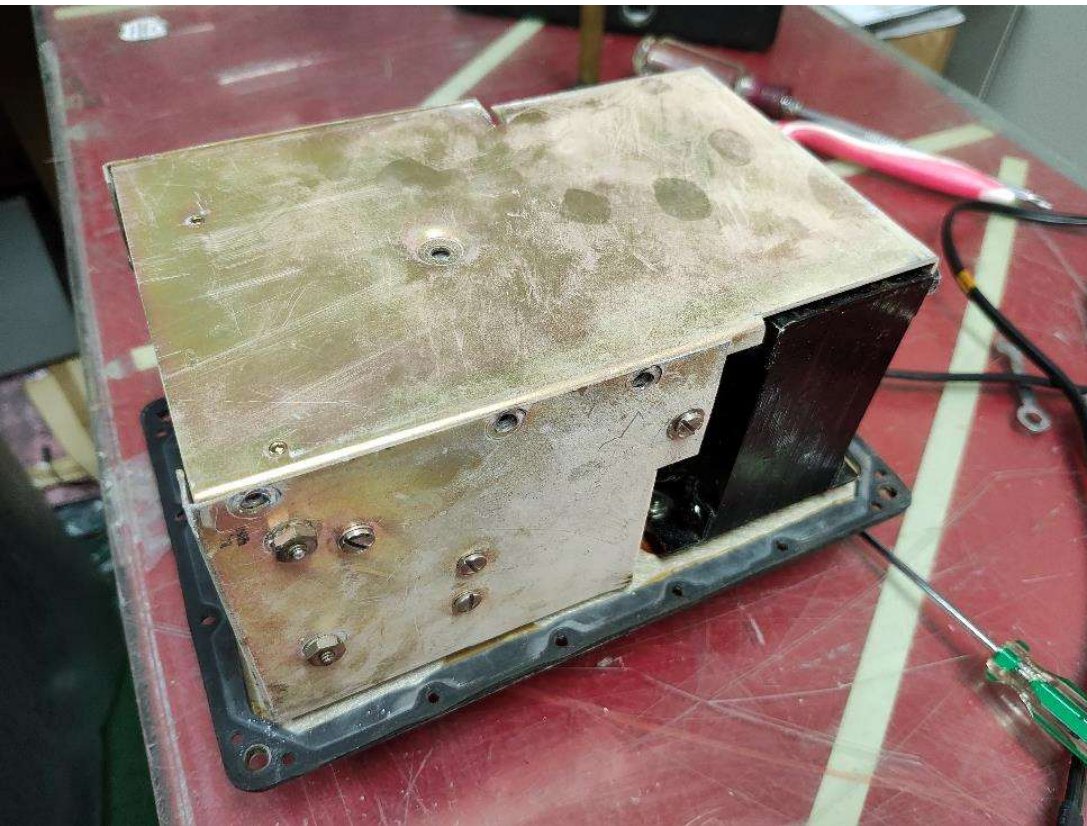
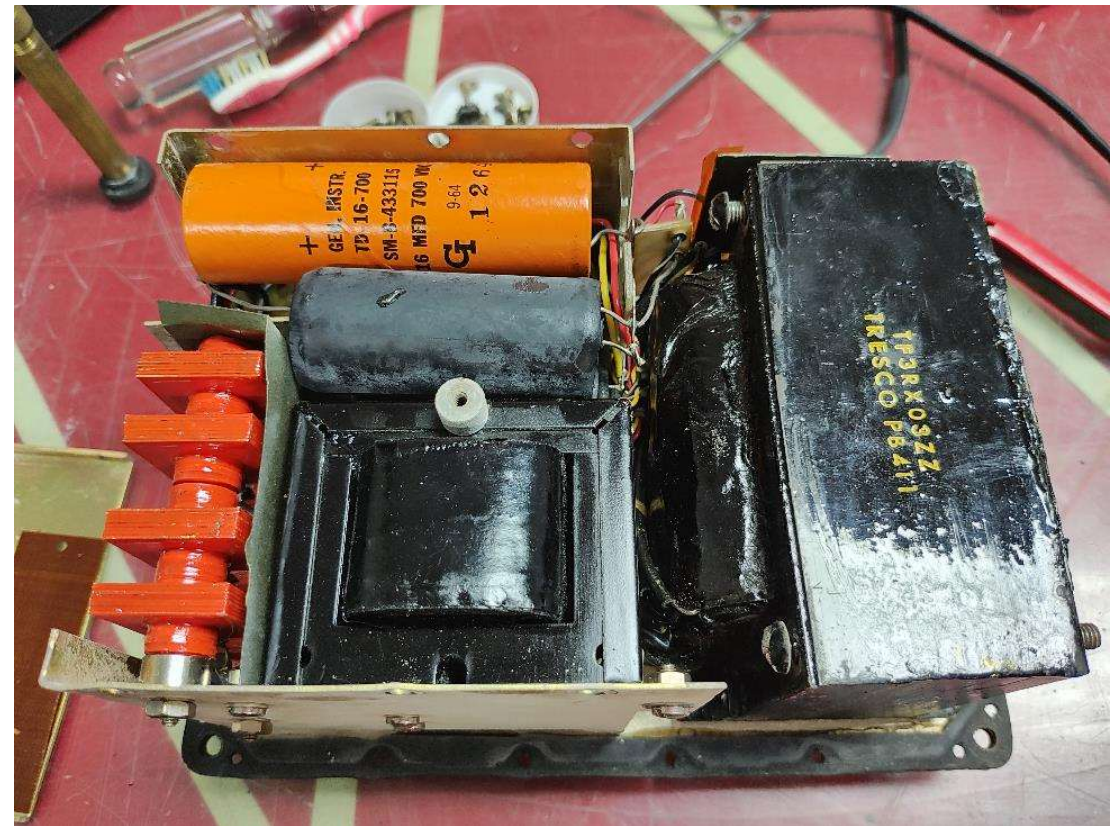
- Unit operational, Oct-2023 opened for routine inspection after receiver tube failure
- Capacitor leaking, 16uF 700V date code 1264, 20uF x 2 450V date code 1264, 2000uF 6V 2pcs date code 1264
- Chassis metal surface stained by evaporated electrolyte, cleaned with Alcohol

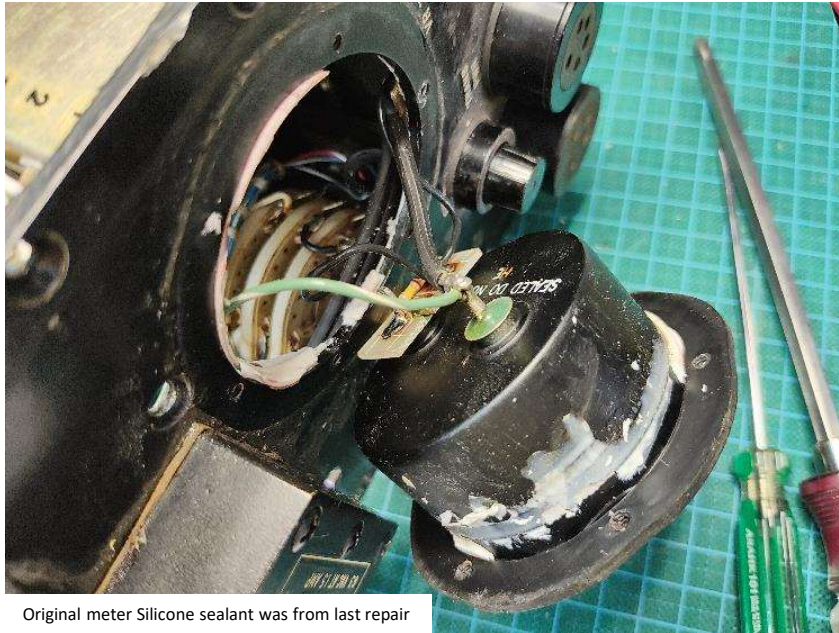
- after almost 20 years meter reads higher voltage, root cause: zero shifted to ~40V mark
 - meter is sealed, unable to adjust unless damaging metal housing

Original meter Silicone sealant was from last repair

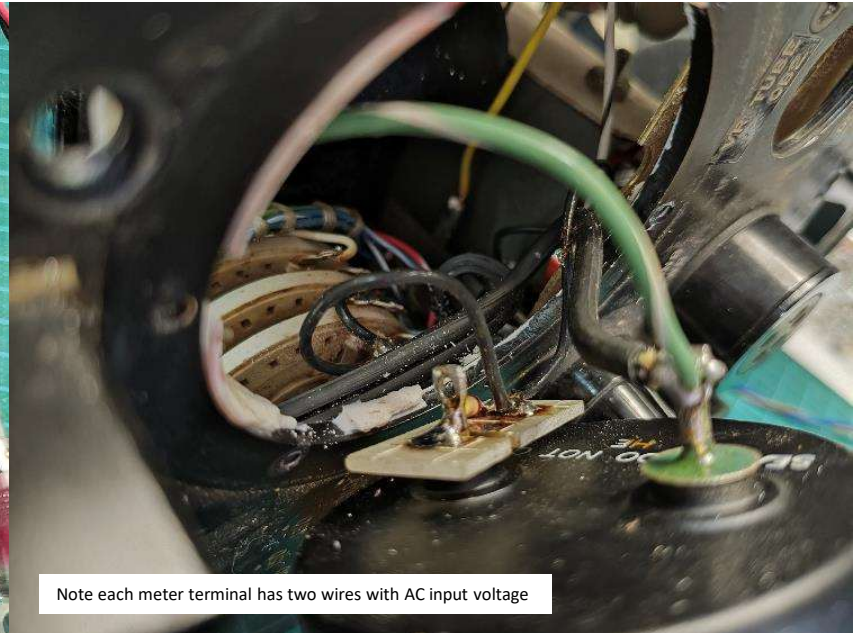
Note each meter terminal has two wires with AC input voltage

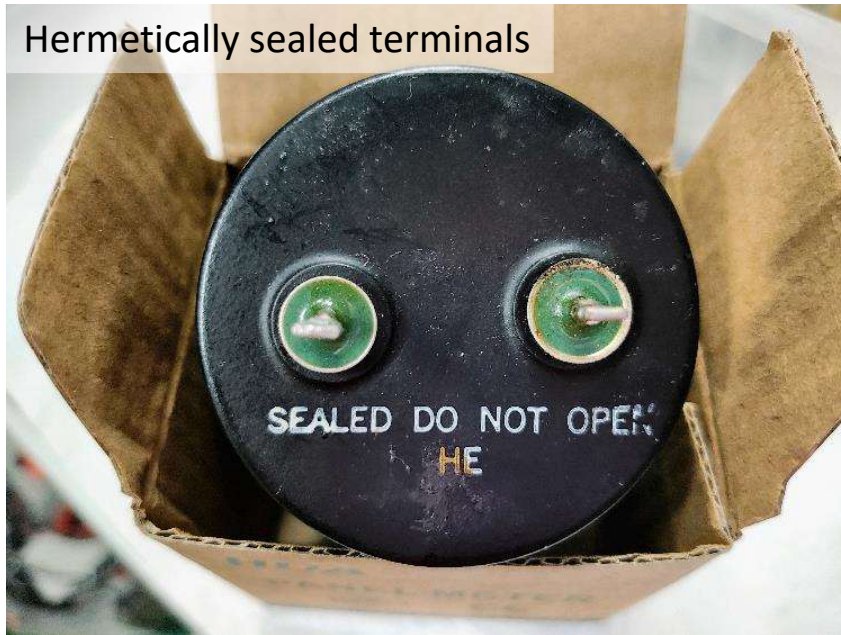
Hermetically sealed terminals

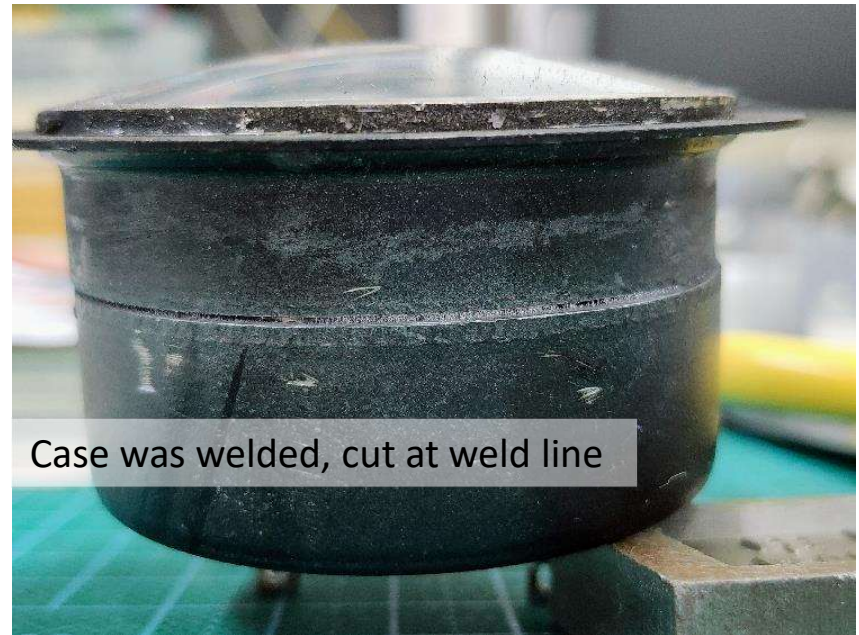
Case was welded, cut at weld line

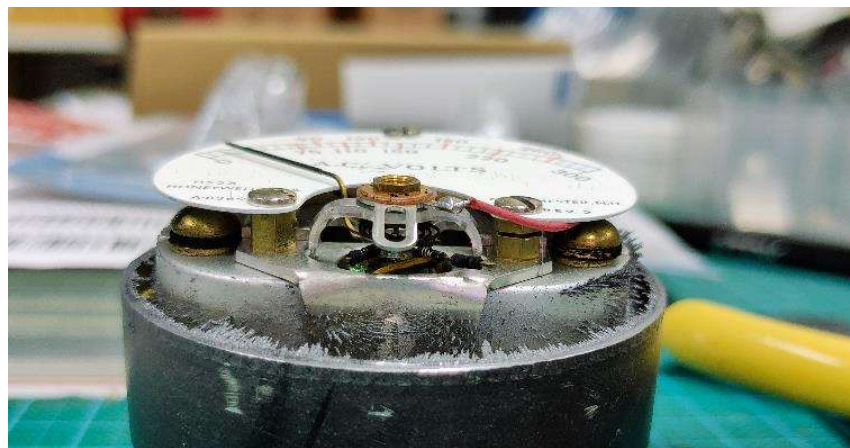
Iron filing is problematic, especially those fell between moving coil and magnet, I used small adhesive tape strips for cleaning
